# BELZONA 3111 (FLEXIBLE MEMBRANE) PROTECTION IN A POWER PLANT

ID: 504

Collapsible roof over conveyor belts - in the area between the coalyard and the boiler.

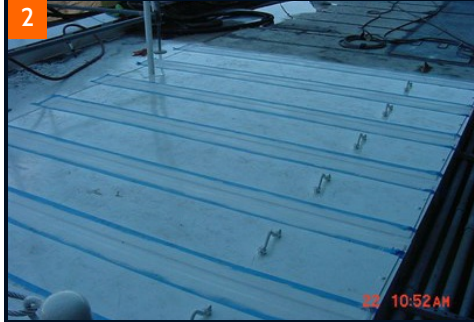
Water getting through collapsible roof seams wets coal and reduces fuel efficiency. Work area extremely dirty due to coal fines from belts.

1. Roof over cascade area prior to the application (note seams).
2. Seam areas taped off.
3. First coat of Belzona 3111 applied.
4. Completed roof. (Roof was painted following the application of the Belzona.)
