# BELZONA REPAIRS STEAM TRAIN FOR UNDERGROUND ANNIVERSARY

ID: 5119

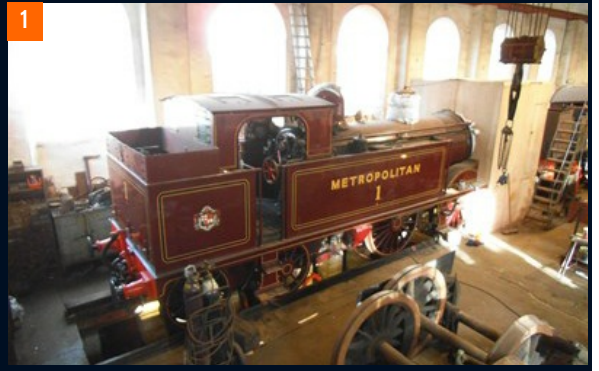
1. Metropolitan number one shown with a heated application hut built around the front nose section
2. Steam chest after grit blasting and application of Belzona 1511 under doubler plates bolted into place
3. Belzona 1391 applied over the doubler plates
4. Belzona 4181 applied as a final protection from foot traffic

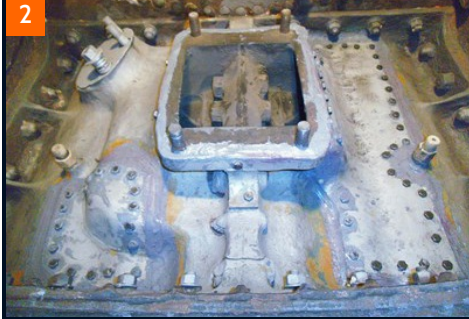
The steam chest (part of the main cylinder block on the train engine) had corroded and had several holes due to steam pressure and the corrosive chemicals wearing it away over many years. Without fixing these holes the engine would lose pressure and fail to run.

Application was carried out in accordance with Belzona Know-How System Leaflets ENC-1 and modified FPA-1. Doubler plates were bonded in place with Belzona 1511 before being coated with Belzona 1391 to provide corrosion protection. Belzona 4181 was then applied to give additional corrosion resistance and resistance to foot traffic during maintenance work. The repair was then overlaid with fire clay to give an authentic appearance.
