# BELZONA REPAIRS & SAVES LARGE SPLIT CASE PUMP AT COAL MINE

ID: 5186

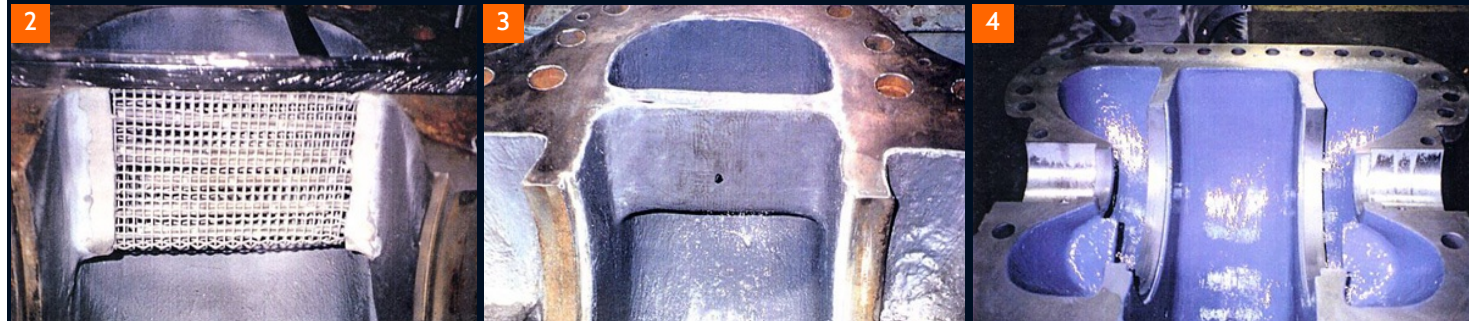
## PHOTOS

Broken cast iron splitter

1. Photograph shows cast splitter missing. Note the evidence of the specialized welding
2. Fabrication of new splitter in progress
3. Fabrication of new splitter completed with the mesh area filled with Belzona 1311
4. Pump internals completely protected with 2 coats of Belzona 1321

The splitter of this cast iron Worthington split case sludge pump had broken away. The mine engineers had originally discarded the “Belzona fix” and insisted that a new cast section be made and welded into place. This was duly done at great expense. The new splitter was “faired in” with Belzona 1311 and the pump internals coated. After operating for only a few weeks the pump started producing a rattling sound and on further inspection it was found that the new splitter had come adrift and the only thing keeping it in place was the Belzona product used to “fair it in”. Because there was no replacement, it was decided to go ahead with the Belzona repair originally suggested but turned down.

After the 2nd repair using the Belzona solution the pump was returned to service and operated for 2 years at which stage it was removed to replace bearings and packings. An inspection revealed that the fabricated splitter was still in first rate condition and that coating applied to the pump to protect it from sliding abrasion was still in perfect condition. Afterwards, the overall the pump was returned to service.
