# BELZONA PROTECTS PARAPET WALLS FROM WATER PENETRATION

ID: 5240

Parapet walls of a condominium building.

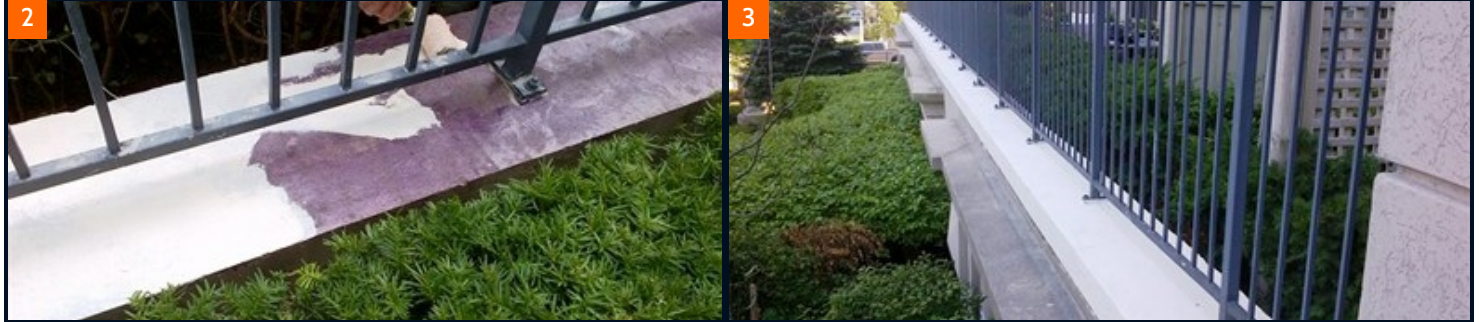
Water was penetrating the concrete.

1. Prior to application
2. Application in progress
3. Completed application

The application was carried out in accordance with Belzona Know-How System Leaflet RPA-10 for sealing leaking areas in parapet walls and copings. A wire brush was used to prepare the surface and brushed off to remove all the dust. Belzona 3911 was applied with a brush to the entire surface. Belzona 5131 was applied with a lambs wool roller in accordance with Belzona Instructions For Use.
