# LOADING DOCK DRAIN COATED WITH BELZONA

ID: 5242

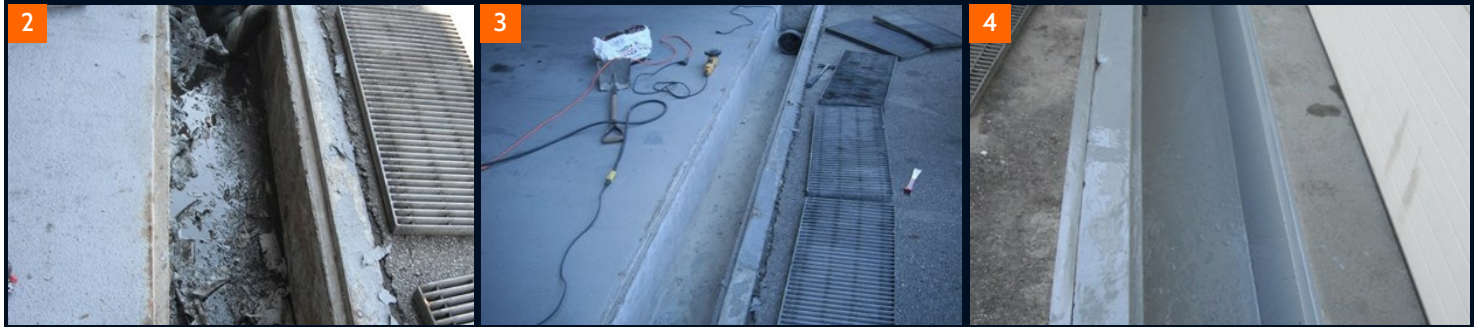
The existing coating had failed, causing blockage of the drain.

1. Prior to application
2. Preparation in progress
3. Application in progress
4. Completed application

The application was carried out in accordance with Belzona Know-How System Leaflet FPA-3 for protecting floors and drains against chemical attack. The surface was prepared for application by removing the existing coating and cleaned with a high pressure washer. Belzona 5811 was applied as a two coat system with a short bristle brush.
