# BELZONA OFFERS SLIP RESISTANT COATING ON STAIRCASE

ID: 5243

Staircase access to car park.

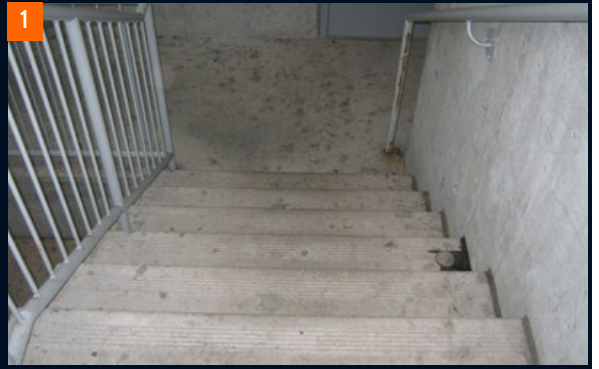
The customer wanted a coating that was slip resistant and offered protection from salt contamination.

1. Prior to application
2. Completed application
3. Completed application

The application was carried out in accordance with Belzona Know-How System Leaflet FPA-3 for protecting floors and drains against chemical attack. The surface was prepared by power washing the surface to remove dirt, debris and salt contamination. A diamond grinder was used to abrade the surface and remove small floor imperfections. Belzona 5231 was applied for the first coat and Belzona 9221 was broadcasted for increased antiskid properties. A second coat of Belzona 5231 was applied within the overcoat window in accordance with Belzona Instructions For Use.
