# BELZONA COATS FLOORS FOR PROTECTION AGAINST CHEMICAL ATTACK

ID: 5245

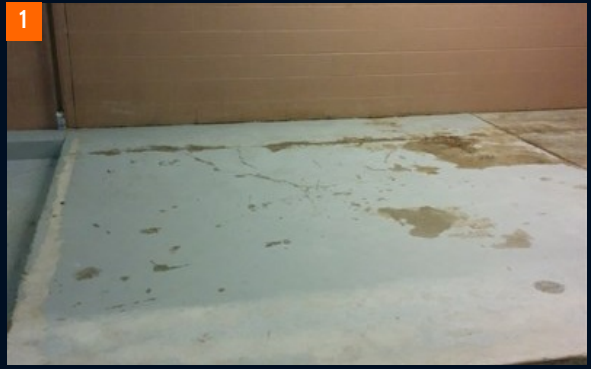
Waste was causing chemical attack so the customer wanted a coating to protect the flooring.

1. Prior to application
2. Preparation in progress
3. Completed application

The application was carried out in accordance with Belzona Know-How System Leaflet FPA-3 for protecting floors and drains against chemical attack. The floor was prepared for coating using a floor sander to remove any existing coating, dirt and debris and abraded to expose the aggregate. Belzona 5231 was applied using a medium nap roller in accordance with Belzona Instructions For Use.
