# STEEL OF A RAILWAY PROTECTED WITH BELZONA

ID: 5253

Corrosion on the steel of a railway.

Railway at a museum.

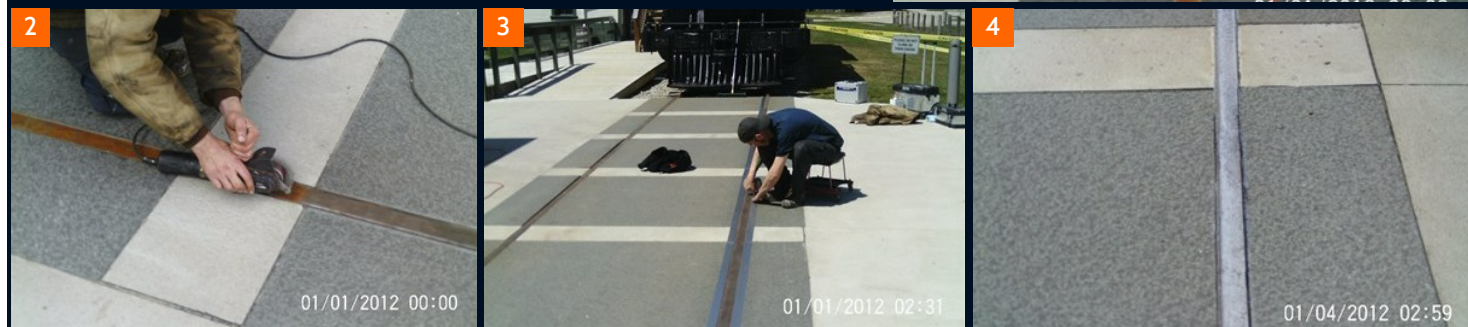
## PHOTOS

1. Prior to application
2. Preparation in progress
3. Preparation in progress
4. Completed application

The application was carried out in accordance with Belzona Know-How System Leaflet FPA-3 for protecting floors and drains against chemical attack. A MBX bristle blaster was used to remove any rust and to prepare the surface for application. Belzona 4151 was brush applied in accordance with Belzona Instructions For Use.
