# BELZONA 1111 (SUPER METAL) MOUNTS CELL PHONE ANTENNAS AT 220'

ID: 5255

## PROBLEM

Local water authority required a cold cure mounting system to bond the plates to the top of the water tower.

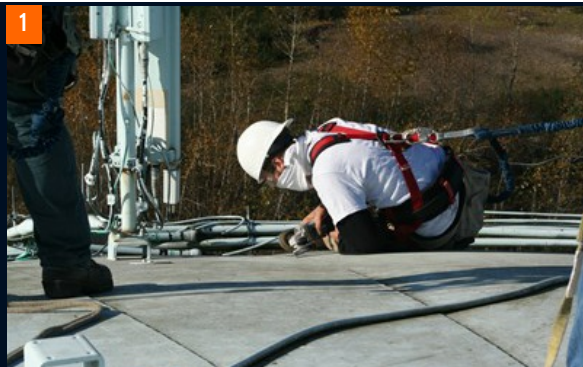
1. Surface preparation
2. Surface ready for application
3. Plate mounted carefully over uneven surface
4. Belzona technical Consultant and the crew after the job is done (Mt. Rainier in the background)

Standard instructions followed as stated in the IFU for the Belzona 1111. As seen in the pictures, some of the mounts were forced to be on uneven surfaces and over weld lines. Special care was taken to ensure the existing paint was removed from the rough surface of the weld without compromising the integrity of the weld itself.
