# BELZONA PROTECTS TANK FROM CORROSION AND CHEMICAL ATTACK

ID: 5310

Slurry tank for water and solvents.

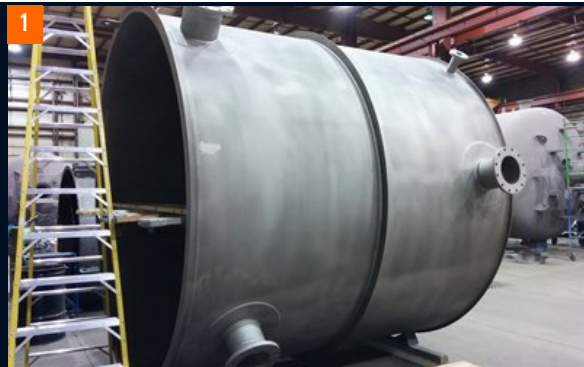
1. New build tank
2. Prior to application
3. Application in progress
4. Completed application

The application was carried out in accordance with Belzona Know-How System Leaflet TCC-3 for repairing/renewing damaged linings. Belzona 5892 was applied using a brush as a two coat system in accordance with Belzona Instructions For Use.
