# BELZONA PREVENTS H2S GAS FROM ESCAPING WASTEWATER HATCH

ID: 5311

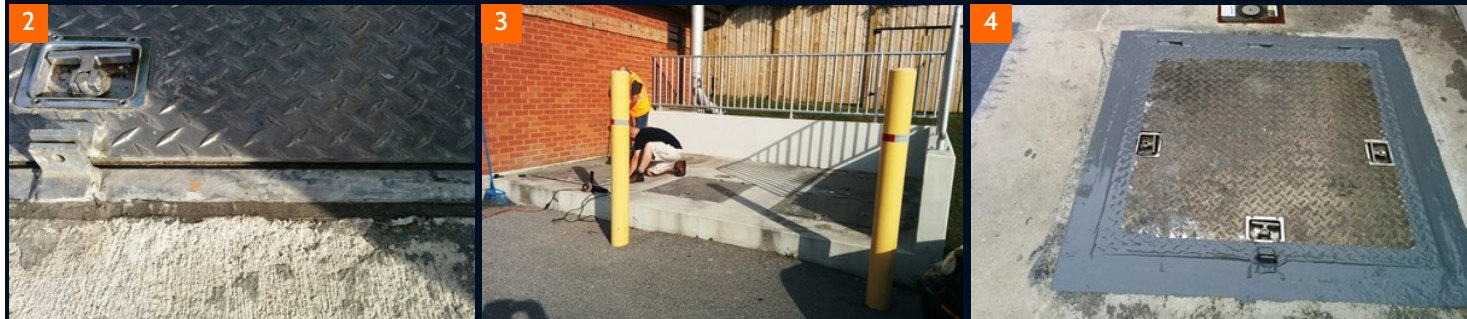
## PHOTOS

Mid-pump station close to residential housing created excessive H2S gas smell and was a concern to local residents.

Access hatch to underground vault.

1. Prior to application
2. Prior to application
3. Preparation in progress
4. Completed application

The application was carried out in accordance with Belzona Know-How System Leaflet TCC-15 for sealing and protecting containment areas. The area was ground using a grinder to prepare the surface. Belzona 3121 was applied using a brush as a two coat system in accordance with Belzona Instructions For Use.

Hatches were sealed to prevent the smell of gas escaping. The waterproof coating will remain flexible and handle both summer and winter weather conditions. Belzona 3121 is a two-component emergency repair and weatherproofing system for the sealing of all types of roof surfaces. This fluid grade material is designed for instant waterproofing and can be applied under most year-round weather conditions.
