# BELZONA PROTECTS MAIN ON A MIXING TRUCK AGAINST ABRASION

ID: 5316

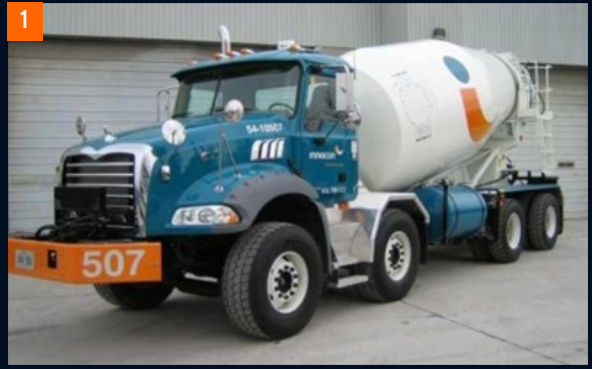
1. Concrete mixing truck
2. Main prior to application
3. Preparation in process
4. Completed application

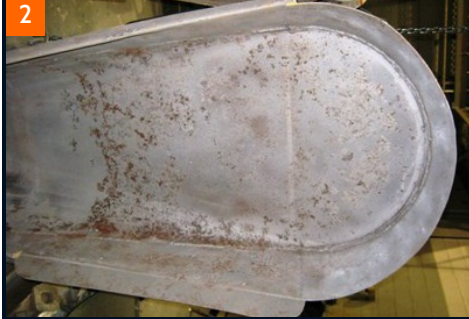
Impact and abrasion caused by flowing concrete.
