# BELZONA PROTECTS PAPER MILL FAN PUMP

ID: 5352

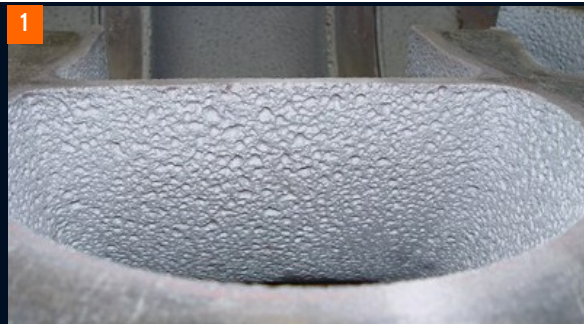
Pumping stock at 125° F, with calcium carbonate added, goes through a boil out process using sodium hydroxide and phosphoric acid at 165° F. With the wear on the casing, it is just a matter of time before the chemicals create a hole.

1. Grit blasted, ready to be coated
2. Filling pits with Belzona 1111
3. Coating with Belzona 1391T
4. Completed application to pump casing

The pump was grit blasted. Belzona 1111 was used to fill all the pitting. Two coats of 1391T were brushed on.
