# BELZONA COATING FOR A CHEMICAL TANK

ID: 5361

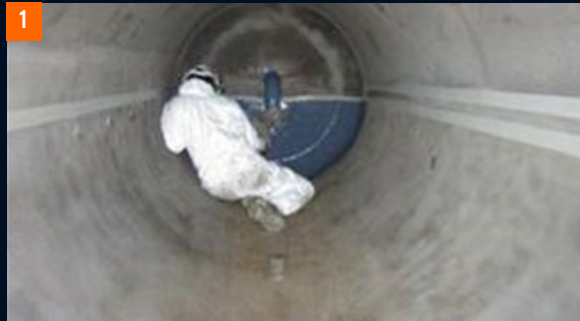
1. Tank after blasting,
2. Beginning of the application
3. On-going application of the coating  
Finished application

The application was done in accordance to Belzona system leaflet TCC-5. After degreasing and blasting the surface, Belzona 1391 was applied in a one coat system (600 to 750µm) on the bottom part of the tank.
