# PROTECTION OF A CHEMICAL TANK AT VERY HIGH TEMPERATURE

ID: 5362

Tank F110 (diameter : 3m, height : 3,1m)

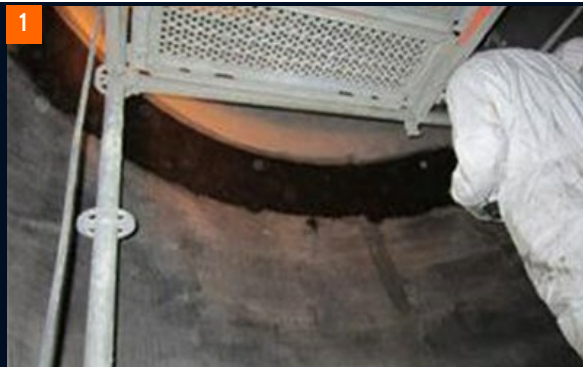
Tank made of steel can be easily attacked by chemicals at high temperature (165°C)

1. Blasted surface,
2. On-going application,
3. Finished application

Application realised in accordance to Belzona system leaflet TCC-5. After degreasing and blasting, Belzona 1591 was applied in a one-coat system (between 600 and 800µm).
