# BELZONA KEEPS THE RAIN OFF THE SHOP FLOOR

ID: 5377

Pump shop forklift traffic area

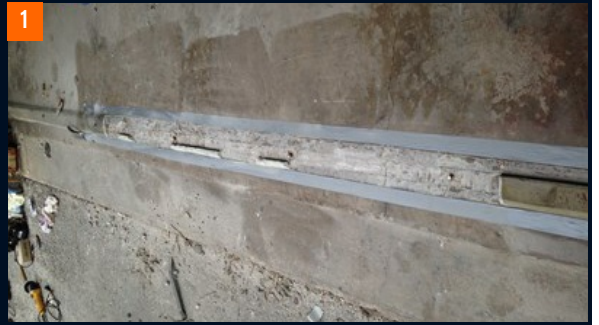
1. Application area being prepared
2. Belzona 4111 being applied to wet out the surface
3. Completed curb using Belzona 4111

Application was carried out using a modified version of Belzona Know-How System Leaflet FPA-1. After proper surface preparation a thin layer of Belzona 4911 conditioner was applied for proper bonding. Belzona 4111 was then used to form the curb.
