# BELZONA IMPROVES EFFICIENCY OF JET DUCTS

ID: 5386

## PROBLEM

Water flow through the ducts needed to be improved along with a decrease in surface turbulence

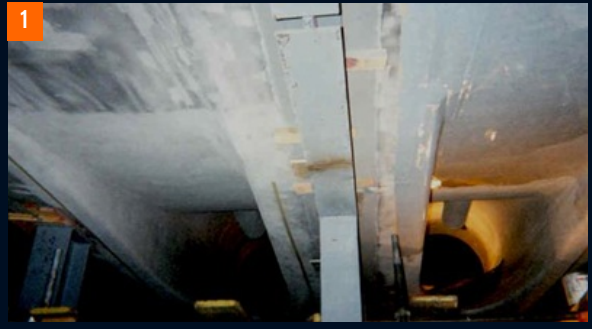
1. View of ducts after grit blasting.
2. Application of 1st coat of Belzona 1341 (Grey) in progress.
3. Completed application of 2nd coat of Belzona 1341 (Blue).

The application was carried out in accordance with Belzona Know-How System Leaflet SOS-2.
