# BELZONA PROTECTS AGAINST HOT SULPHURIC ACID

ID: 5475

Tile and brick chemical containment bund.

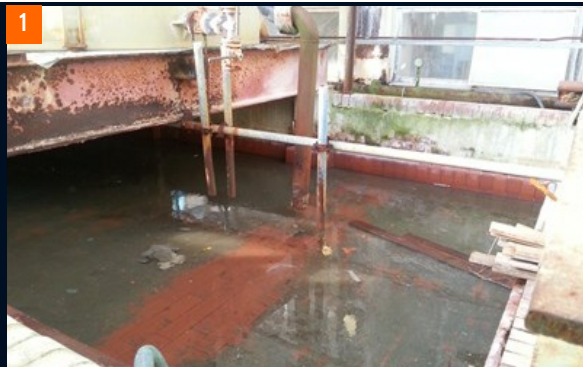
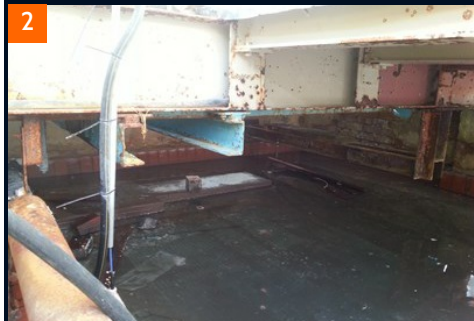
The tiles were on the base of the bund and a couple of inches up the walls. As the standing water levels were above the tiles, it was leaking through the bricks. The tank inside was storing 77% sulphuric acid at 70°C. It was therefore decided to coat the bund.

1. Damaged bund area
2. Damaged bund area
3. & 4. Completed application

The application was carried out in accordance with Belzona Know-How System Leaflet TCC-15. Belzona 4131 was used to create fillets at the horizontal and vertical junctions before Belzona 4341 was applied to protect the entire area.
