# BELZONA BONDS RISER BEARINGS ON OFFSHORE PLATFORM

ID: 5539

Risers and Riser housings needed protection on a new build Central Processing Facility.

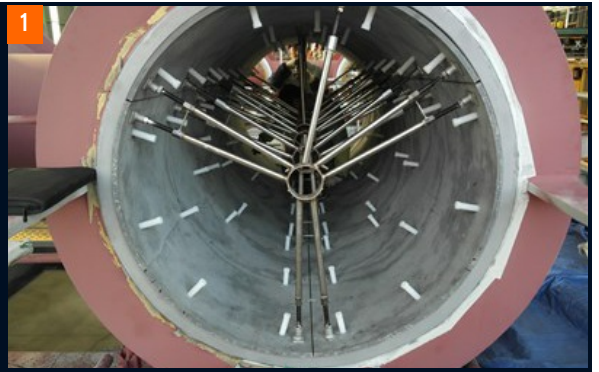
1. Fitting Bearing to Housing
2. Fitting Bearing to Riser
3. Injecting Belzona 1321
4. Riser inserted into Housing

The application was carried out in accordance with Belzona Know-How System Leaflet GSS-9. The Bearings were aligned in place using jigs, straps and injection port bolts. The Bearing had to be jacked to 4mm from the substrate. The seams were then dammed using Belzona 1111. Belzona 1321 was injected through the injection ports. After curing the injection ports were cut off, filled with Belzona 1111, and ground flush.
