# BELZONA PROTECTS FANS FROM ABRASION

ID: 554

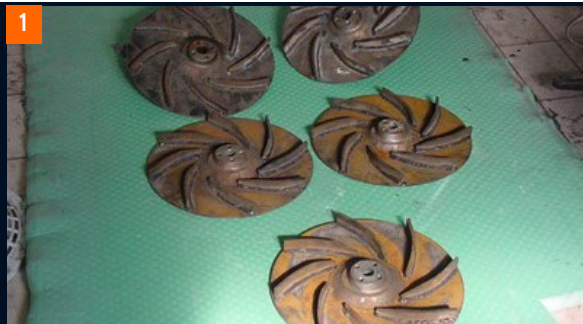
The fans need to be protected from strong abrasion of tobacco which has worn the fans out in only three months.

1. General view of tobacco suction fans
2. Fans following surface preparation
3. Fans coated with Belzona 1812 (Ceramic Carbide FP)
4. Five fans were protected
