# BELZONA SAVES TIME IN A BATTERY STATION

ID: 5562

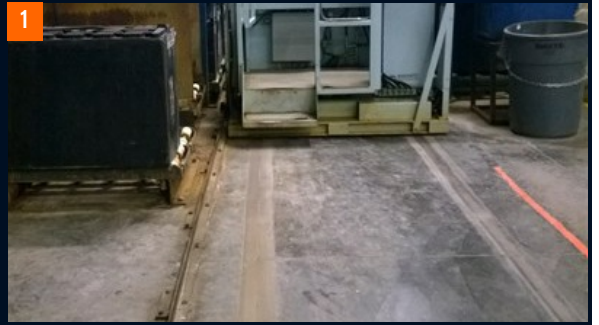
1. Battery forklift in place
2. Battery forklift removed; full view of battery station
3. 8" battery forklift runways being rebuilt with Belzona 4131
4. Completed project before battery forklift was reinstalled

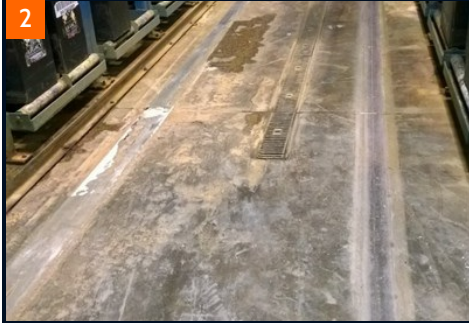
The main path for the current battery forklift was worn to the point where the lift could no longer be used to exchange charged batteries onto the forklifts. The worn pathways were 1/2" to 3/4" deep and 6" wide from the existing elevation. Due to extreme wear from the battery forklift and acid spills on concrete, the 6" wheels had created ruts in the existing concrete, causing damage to the battery forklift that required monthly repairs. The objective was to rebuild 8" wide runways for the battery forklift and provide a protective coating for the Battery acid from runways.
