# BELZONA 1523/1593 HELP COMBAT CORROSION WITHIN AN AMMONIA ACID GAS KOD

ID: 5566

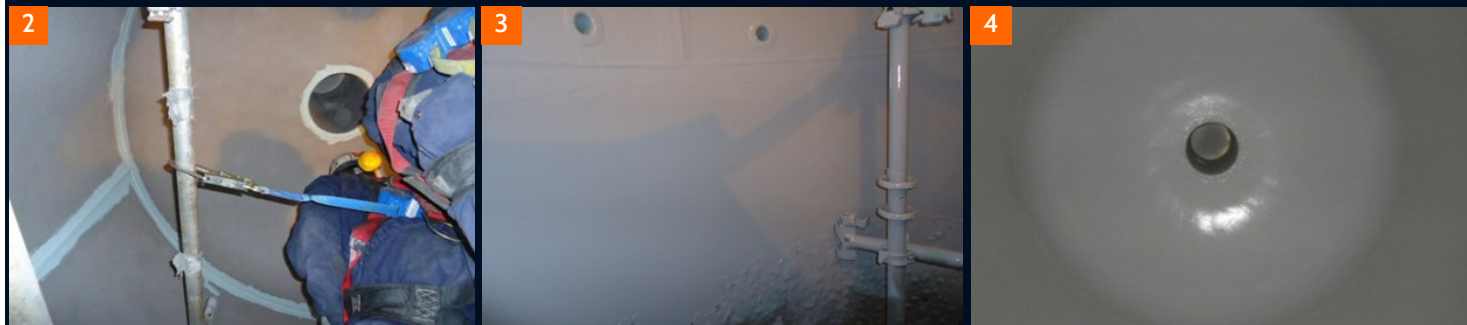
## PHOTOS

1. The surface was prepared by blasting to SSPC SP-10 Near White Metal
2. Stripe coating of welds and sharp angles with Belzona 1593
3. Application of the 2nd coat of Belzona 1523 in light grey
4. Complete application

The application was carried out in accordance with Belzona Know-How System Leaflet TCC-5. After grit blasting to SSPC-SP 10, the surface was Bresle tested for salt soluble contaminants, cleaned, and degreased with Belzona 9111. Due to high levels of relative humidity, a dehumidifier unit was utilized to prevent flash rusting of the prepared surface, thus avoiding any risk of corrosion prior to coating. Following this, Belzona 1593 hand applied lining was used for stripe coating and nozzle lining. The crew continued with the application of Belzona 1523 using a plural component Graco airless spray system. The coating was applied as a two-coat system with contrasting colors. The application was reported to be a success and the material was found to "spray beautifully". Coating was allowed to cure for inspection. High voltage test was conducted and spotted pinholes were repaired accordingly using Belzona 1593.
