# REPAIR OF THE DAMAGED MOTORCYCLE FORK COVER KTM

ID: 5575

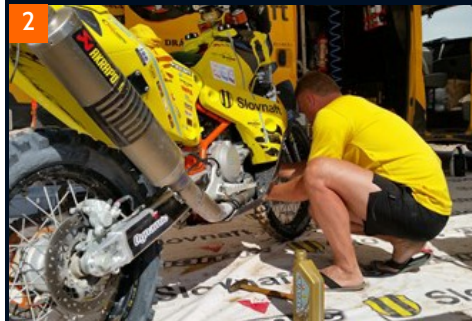
1. Slovak rider (supported by Belzona products) with escort repair truck - fifth overall bike on the Dakar rally 2015
2. Repairs in the field conditions
3. "Emergency" repair of the damaged motorcycle fork cover KTM hold for the all race (photo from after rally promotion show)
4. Motorcycle KTM - after rally promotion show

Application was carried out in accordance with Belzona Know-How System Leaflet ENC-1 in field conditions. The cover was dismounted, ragged by steel brush, cleaned and recovered with Belzona 1221 together with Belzona 9341.

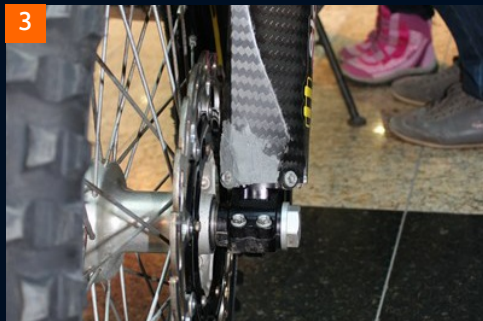
It is one of the arduous rallies in the world. Riders need to repair their machines on the run or in the evening in hard field conditions. So it is perfect for them to carry some products, which they can use due to its fast curing characteristics and which are ideal for emergency repair situations. When was broken motorcycle fork cover KTM, they have used the Belzona products to repair it.
