# BELZONA RESIN CHOCKS FOR DREDGER BOILER

ID: 5582

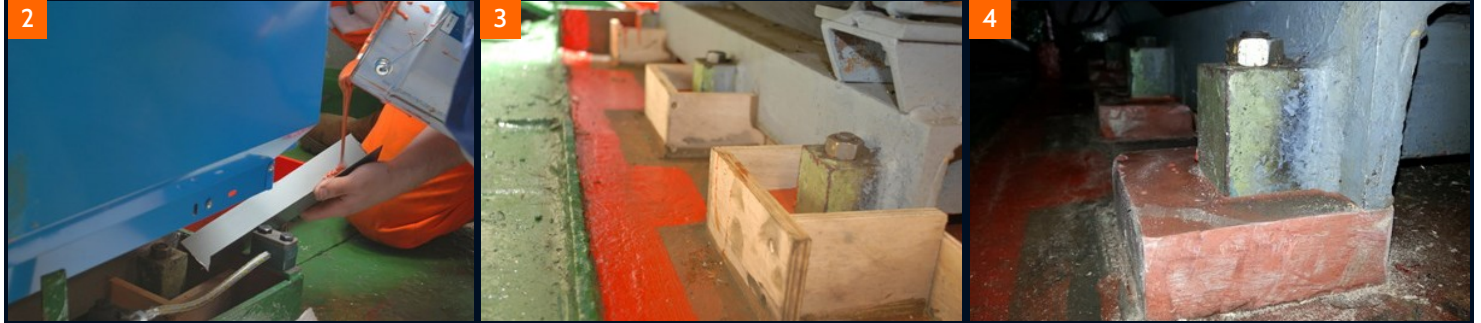
1. The boiler set in place
2. Pouring Belzona 7111 into the prepared area
3. Product curing around bolts
4. Completed application with dams removed

The application was carried out in accordance with Belzona Know-How System Leaflet GSS-12. The boiler was set into place using jacking bolts, and dams were built around each of the individual bolts. Belzona 7111 was then poured into the prepared areas using a small section of steel as a runway due to the difficult access. The thickness of the pour was just over 2 inches, so a solidifier reduction was used.
