# DOUBLER PLATES BONDED WITH BELZONA TO FORECASTLE DECK

ID: 5584

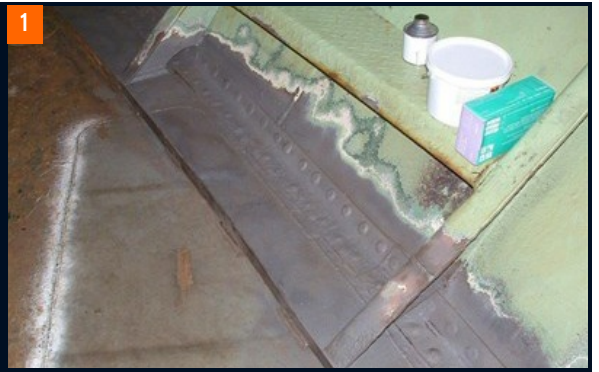
The width of exposed deck plating has had thickness measurements carried out throughout its life and has shown signs of thinning. They needed to replace the lost metal and reintroduce the corrosion allowance, as the guttering is classed as part of the green deck (structural integrity of the deck), welding would require the area to be heat treated post welding to relieve any stress created by the welding.

1. View of Forecastle "Gutterway"
2. Application of Belzona 1151
3. Plate bonded to the deck
4. Completed application
