# BELZONA HIGH TEMPERATURE LINING FOR NEW AUTOCLAVE

ID: 5641

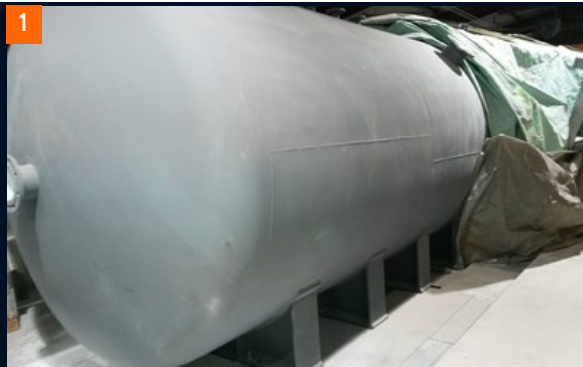
1. Outside view of autoclave
2. Autoclave ready for grit blasting
3. Lining application in action
