# BELZONA KEEPS WIND TURBINES SPINNING

Wind Farm, Teesside, UK

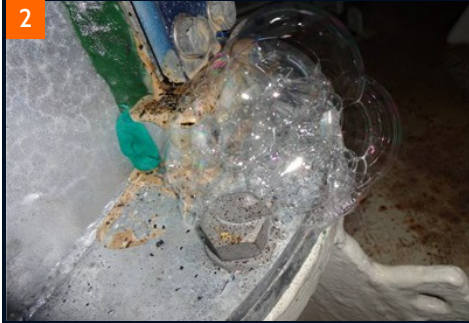
Many of the flanges were not gas tight. Changes in tide led to dangerous gases seeping from the seabed and into the chamber. A temporary sealant had been applied but could not effectively seal the leaks and a permanent solution was required.

1. View of the wind farm
2. Leaking flange
3. Second leaking flange
4. Belzona solution applied

Belzona, Belzona's UK application division, was signed on to carry out the repairs with the application in accordance with Belzona Know-How System Leaflet VPF-11. After removing the temporary repairs and preparing the surfaces, Belzona 1161 was used to pack the joint and seal the nuts and bolts using caps filled with product. Two coats of Belzona 5831 were applied onto the flange tops and bottoms to ensure a lasting protection and to eliminate any risk of leaks.
