# BELZONA PROTECTS OIL PIPE LINES

ID: 570

Welding seams of the pipe lines need to be protected from corrosion.

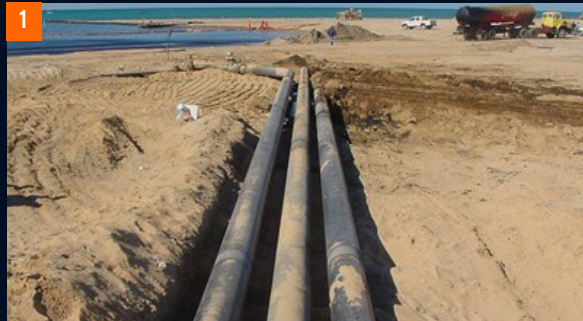
1. Crude oil pipe lines
2. Welding seams of the pipe lines
3. Applying Belzona 5891
4. Application carried out on all welding seams of the pipe line

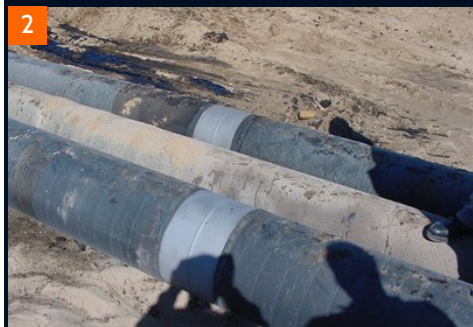
Pipe line welding seams were weak due to welding and need to be protected from corrosion that will be accelerated due to salts in air from the sea and high temperature. Belzona provides this protection.
