# BOSCH CHAINLESS DIFFUSER COATED WITH BELZONA

ID: 5703

A brand new Chainless Diffuser designed by Bosch & Associates was built on site at Illovo Ubombo in Swaziland. The entire internal structural steel work and piping required an erosion and corrosion resistant coating applied to the new steel prior to assembly.

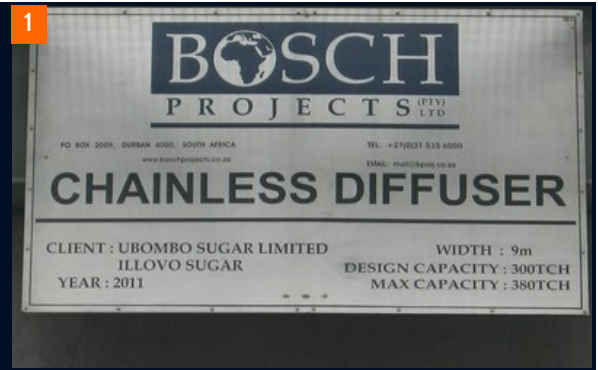
1. Chainless Diffuser designed by Bosch & Associates
2. General view of the sugar plant
3. Structural Steelwork coated with Belzona 5891
4. Steam inlet pipes coated with Belzona 1391
