# BELZONA PROTECTS CONCRETE FLOOR AGAINST OIL CONTAMINATION

ID: 5836

Floor in an auction barn.

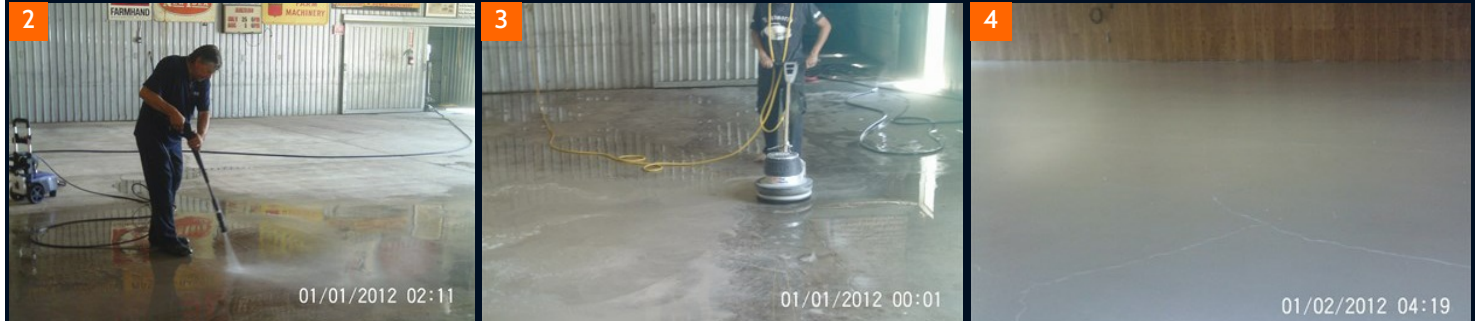
1. Prior to application
2. Preparation in progress
3. Preparation in progress
4. Completed application

The application was carried out in accordance with Belzona Know-How System Leaflet FPA-3 for protecting floors and drains against chemical attack. A jet wash was used to clean the floor of any contamination and a diamond grinder was used to prepare the floor. Belzona 5231 was applied to the surface as a two coat system using a medium nap roller in accordance with the Belzona Instructions For Use.
