# BELZONA PROTECTS DOOR TO DIGESTER AGAINST CORROSION

ID: 5838

Door to a digester at a Waste Water Plant.

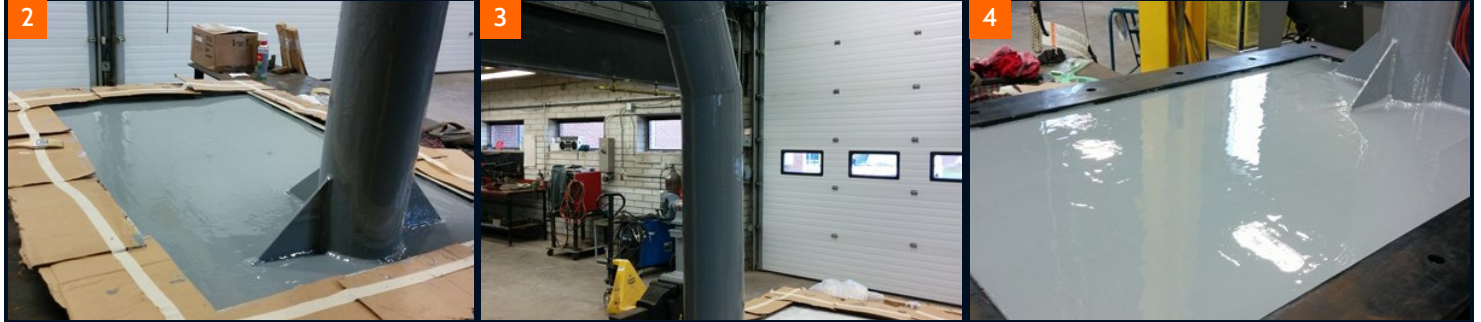
## PHOTOS

The previous door was suffering from corrosion. The customer wanted long-term protection on the new door prior to installation.

1. Prior to application
2. Application in progress
3. Application in progress
4. Completed application

The application was carried out in accordance with Belzona Know-How System Leaflet VPF-2 for applying erosion-corrosion resistant coatings. A grit blaster was used to prepare the surface. Belzona 5811 was applied as a two coat system using a short bristle brush in accordance with the Belzona Instructions For Use.
