# BELZONA PROTECTS PUMP FOUNDATIONS

ID: 584

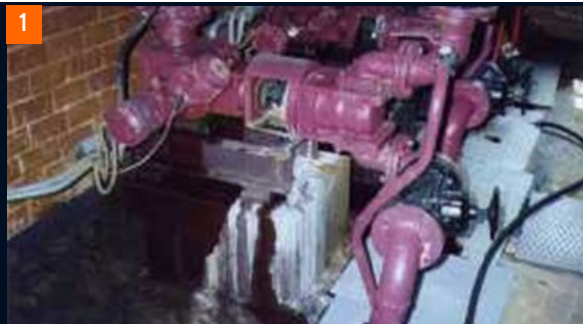
Leaks from the pumps destroy their unprotected concrete foundations.

Belzona® 4311 provides complete protection from the chemicals used in the water treatment process. There is no damage after 1½ years service.

1. Before coating applied
2. 1½ years after application

The application procedure was carried out in accordance with Belzona Know-How System Leaflet TCC-15.
