# BELZONA BRIDGE REPAIR PLATE BOND

ID: 5889

Bonding reinforcing plates to steel box girder bridge.

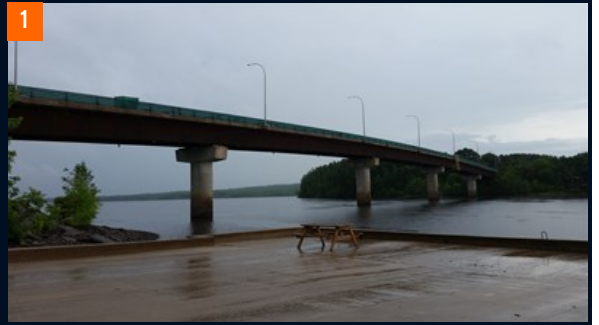
Water leaking inside the bridge box girder had caused excessive corrosion. Pits, through-wall defects and thin areas were in need of reinforcement. Due to extreme corrosion in the area adjacent and including the splice plates, welding was not an option. Bolting plates and using Belzona to reinforce the irregular surface was the best course of action.

1. View of the bridge
2. Belzona 1121 being applied to perimeter
3. Injection of Belzona 1151
4. Completed Application
