# BELZONA SEALS AND PROTECTS RISER NEOPRENE SLEEVE INTERFACE

ID: 5895

2", 4", and 6" riser/sleeve interface on offshore production platform.

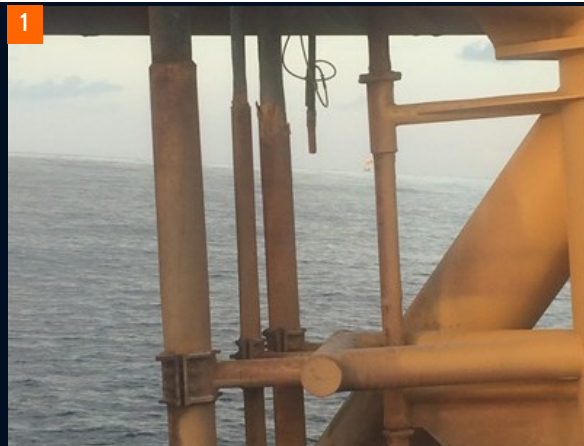
Poor adhesion of the neoprene sleeve on 3 risers allowed corrosion to develop between the sleeve and pipe wall, causing further deterioration of the riser. The asset owner required a suitable solution without downtime or loss of production.

1. Condition of neoprene sleeve and riser interface.
2. Neoprene sleeve cut back and surface preparation underway.
3. First coat of Belzona 2131 with Belzona 9341 installed.
4. Repair completed on 3 risers.
