# BELZONA EXTENDS THE LIFE OF LIME SLURRY ELBOWS

ID: 5915

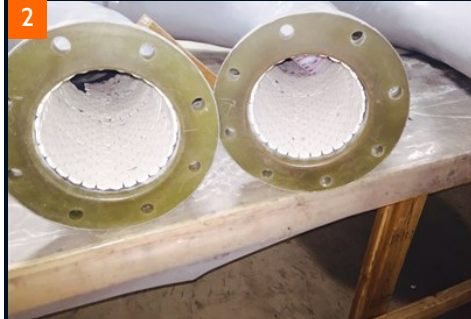
1. Surface preparation
2. View of the inside and application of Belzona 9811 tiles
3. Finished backing
4. Belzona 1812 was sloped over and into the tile to not leave an edge for the lime slurry to get under

The customer had the elbow's inner diameter made 1/2" bigger to allow for the thickness of the applied Belzona products. This was done to avoid the original diameter to become enclosed, which would create a smaller area of the inner diameter and create more vortex that would result in the elbows wearing faster. The surface preparation was carried out using a MBX bristle blaster. Then, a thin layer of Belzona 1311 was used to bond the Belzona 9811 tiles in place. Belzona 1812 was then used as a grout. The customer also asked we make a thick tiled area on the back of the elbow to see if it would result in lasting longer.
