# BELZONA 7111 PROVIDES CHOCKING TO PROPULSION ENGINE ON FISHING BOAT

ID: 5919

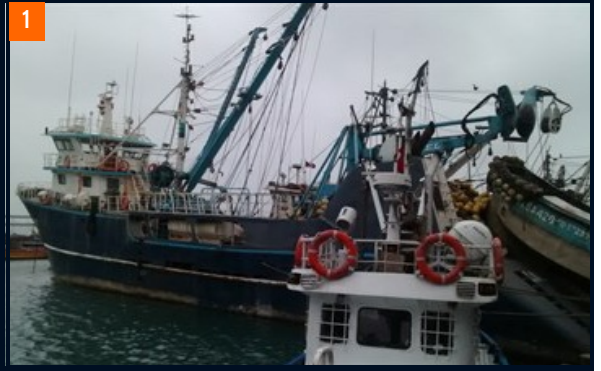
1. Fishing boat with 500 tons of storage
2. View of the main propulsion engine
3. Mixing Belzona 7111
4. Port stern chock finished; the engine has 4 chocks

Maintenance of the propulsion system of the boat, including the propeller, shaft, gearbox and engine, requires realignment of the main engine and the implementation of new foundation chocks that guarantee alignment is maintained and complies with the Marine Certification norms such as Lloyd's Register or American Bureau of Shipping.

The application was carried out in accordance with Belzona Know-How System Leaflet GSS-12, BEL CIS 100 with ABS certification and Belzona 7111 IFU.
