# REDUCTION GEARBOX WITH BELZONA CHOCKS ON FISHING BOAT

ID: 5932

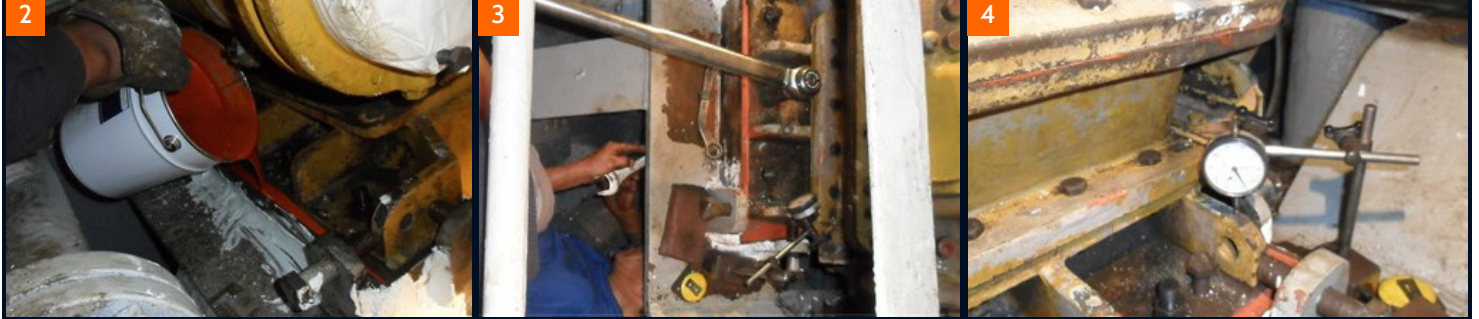
After pouring Belzona 7111 in the two dam casings and after curing was completed, the engine was supported and the anchor bolts were tightened, the variation due to compression was measured and was homogeneous and only 0,001", completely acceptable and safe for alignment.

1. Naval propulsion reduction gearbox
2. Filling the dam by pouring
3. Exact adjustment with torque wrench
4. Completed project with minimum variation which does not affect alignment

The propulsion system has been aligned. The reduction gearbox must be placed on chocks that would not change their height with occasional compression due to weight of the gearbox and the high torque applied to the anchor bolts, and maintain alignment.
