# BELZONA REPAIRS BUTTERFLY VALVE SEALS

ID: 5941

Rubber gaskets on butterfly valves

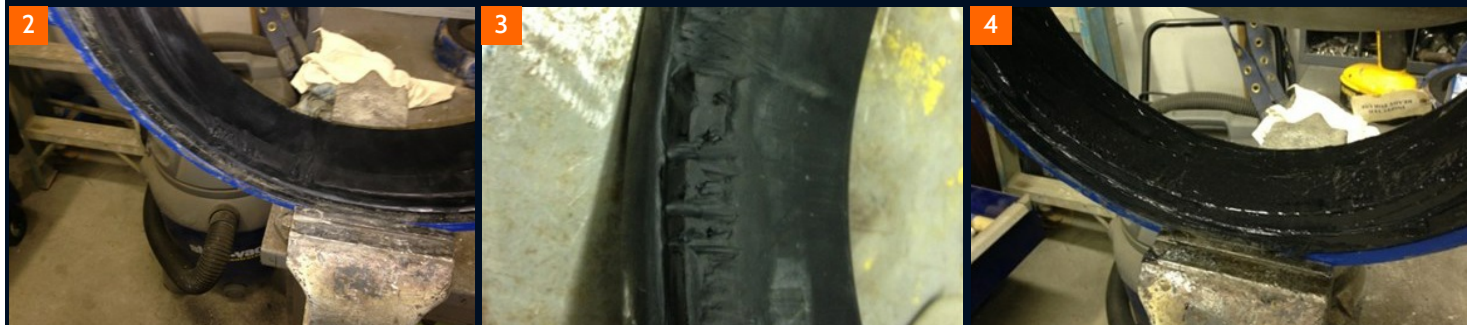
## PHOTOS

The customer uses a cyclone and piping to move cement from barges to silos. Eroded areas at the edge of the valve flappers were allowing small amounts of cement and air to escape around the edges and further eroding the natural rubber.

1. Erosion around the edges of the flapper
2. Erosion more obvious with flapper removed
3. Substrate cleaned and roughened, ready for conditioning
4. Completed application, ready to go back into service

The application was carried out in accordance with Belzona Know-How System Leaflet VPF-1. The substrate was cleaned and roughened using a wire brush and a razor. The effect of the razor was to make dovetail like mechanical bonds. Belzona 2911 was used to condition the surface and allowed to dry for 30 minutes. The surface profile was rebuilt with Belzona 2311 using a Belzona applicator. Alternatively, a release agent could have been used on the flapper and the flapper could have been closed onto the still wet Belzona 2311 to create a perfect seal.
