# BELZONA CALLED IN FOR TOUGH FLOOR REPAIRS

ID: 5942

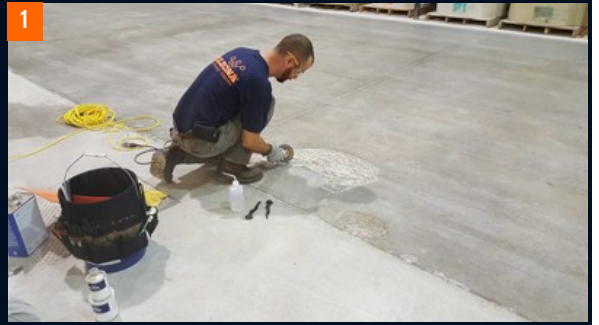
1. Preparing the area with a grinder
2. Conditioning with Belzona 4911
3. Applying Belzona 4111 by trowel
4. Completed application

The application was carried out in accordance with Belzona Know-How System Leaflet FPA-1. The repair area was cleaned using acetone and a rotary wire wheel. An angle grinder was then used with a masonry wheel to prepare the area to allow for an application of at least 1/4" of Belzona 4111. The area was then given a final cleaning with acetone. Belzona 4911 was used to condition the substrate and Belzona 4111 was then trowelled into place and smoothed out. In the warm environment the repair was ready for service in about 4 hours.
