# BELZONA SUPERWRAP II STRENGTHENS CORRODED GAS PIPE

ID: 5962

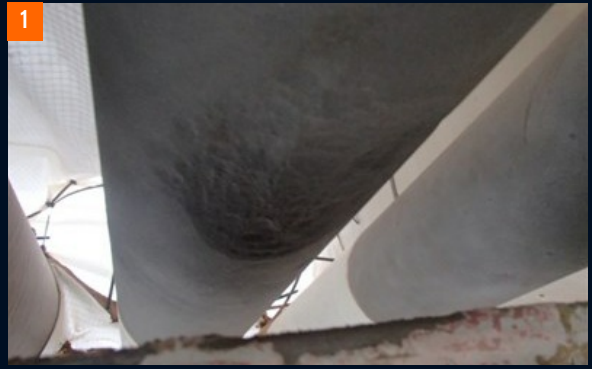
A series of pipes on board the North Sea FPSO were displaying signs of corrosion between the pipe and support. In some areas, registering thin wall defects, with 35% wall loss.

1. Thin-wall corrosion up to 35%
2. Belzona SuperWrap II tackles complex geometries
3. Belzona shim plates at pipe supports
4. Complete Belzona SuperWrap II application
