# BELZONA REPAIRS PORCELAIN SHED

ID: 5964

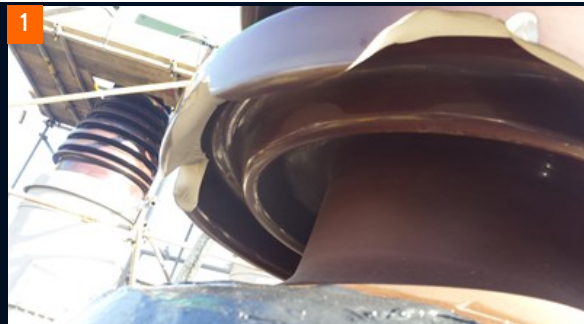
The sub station had a recent outage for routine repairs. During the outage a contractor accidentally damaged one of the porcelain sheds breaking off and cracking parts of the porcelain.

1. The damaged shed
2. The Elastomer applied to create the mold
3. The repair before coating
4. The finished repair with Belzona 4311 applied
