# MOORING WINCH BONDED TO DECK WITH BELZONA

ID: 5974

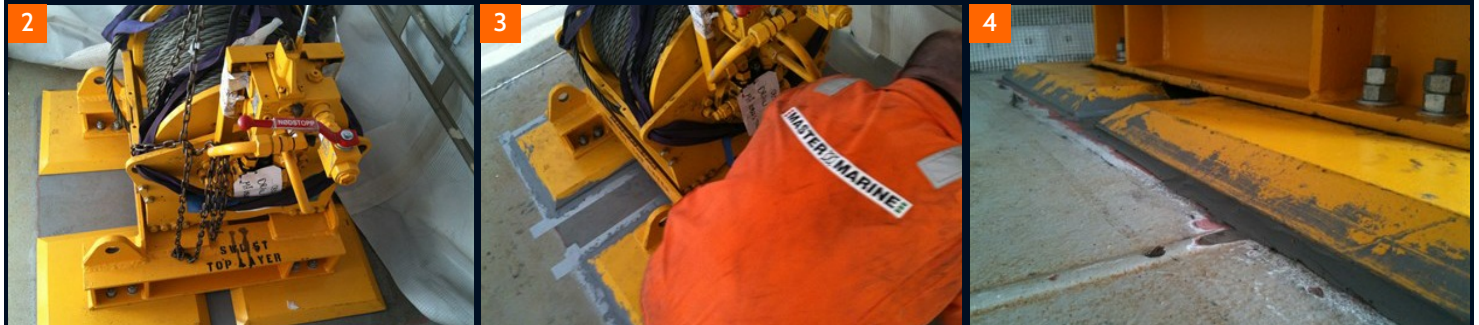
1. View of the deck
2. Dry-fitting the winch
3. Bonding application using Belzona 1111
4. Completed application

The application was carried out in accordance with a modified version of Belzona Know-How System Leaflet GSS-9. Four 450mm x 450mm doubler plates were bonded to the deck with Belzona 1111.

After the application was finished, the winch was tested to 5 tonnes x 1,5 safety factor. The test of 7 tonnes was then executed in cycles. After confirming that the winch can hold 5 tonnes of sideways force for 2,5 hours, the winch assembly was accepted.
