# BELZONA 7111 ACCURATELY LOCATES EXCAVATOR BEARING SEAT

ID: 5976

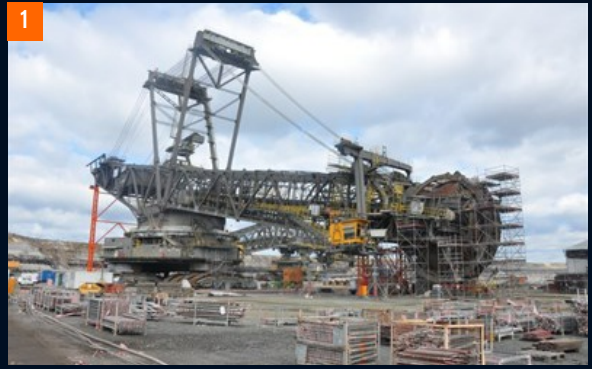
1. The Excavator
2. Measuring substrate temperature
3. Pouring Belzona 7111
4. View of the secured bearing seat
