# BELZONA SUCCEEDS WHERE NOBLE METALS FAIL

Ferrite wheel mixer

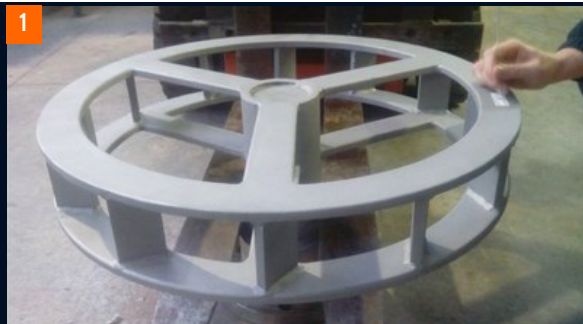
1. Carbon steel wheel after grit blasting
2. One of the templates used for the application
3. Application in progress
4. Completed application

The application was carried out in accordance with a modified version of Belzona Know-How System Leaflet SHM-13. Prefabricated custom made templates were used to carry out the application of Belzona 1811 at a thickness of approximately 10mm on all surfaces of the wheel. Belzona 4151 was then applied to provide a glossy finish.
