# BELZONA 5811 PROTECTS NEW TRASH RACKS AT A HYDRO PLANT

ID: 5979

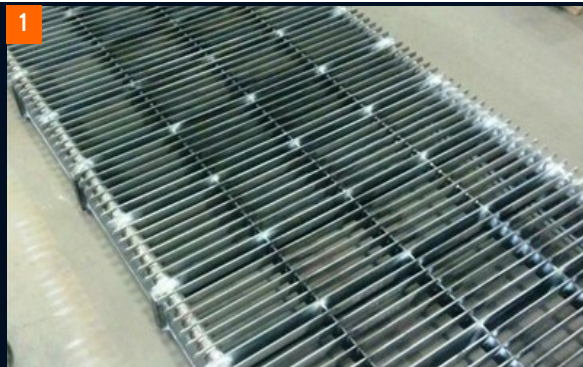
1. Fabricated trash rack with metal grating
2. Fabricated trash gate undergoing NDT inspection to welded joints
3. Belzona 5811 spray applied
4. Close up of Belzona 5811 spray applied to grating
