# BELZONA PROVIDES NON-SLIP SURFACE TO TRANSFER ROLLER

ID: 5996

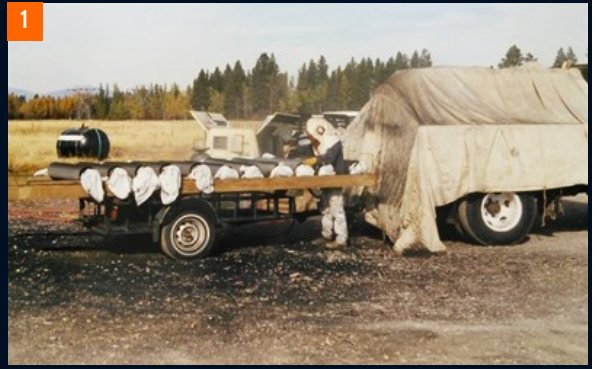
1. Achieving a proper blast profile.
2. Belzona 9111 to clean and degrease before and after blasting.
3. Transfer rollers curing after coating and aggregate applied.
4. Transfer rollers installed and keeping the line going.

The application was carried out in accordance with the IFU for Belzona 5811. The coating was brush applied and the aggregate was spread by hand.

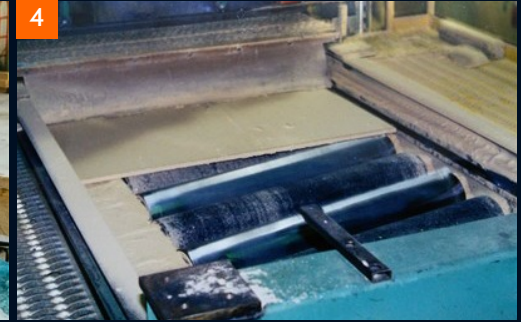
Transfer rollers that move boards downstream of platen press are smooth, causing lack of traction to keep line running.
