# WICKET GATES REPAIRED WITH BELZONA

ID: 6002

Wicket gates at a hydroelectric power station.

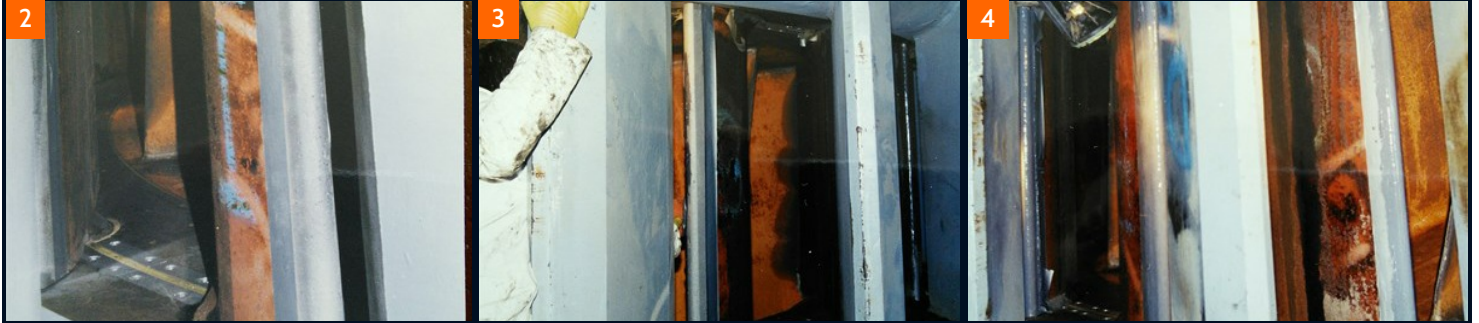
Surface preparation of a previous application was inadequate for the repair of these wicket gates. The coating was failing due to poor adhesion to an improperly prepared surface. Constant erosion and corrosion of these wicket gates caused repeated applications from time to time, but the service times were becoming too frequent in comparison to previous performance.

1. Poor surface preparation caused coating to fail
2. Surface properly prepared
3. Application of Belzona 1321
4. Three wicket gates coated

The application was carried out in accordance with a modified version of Belzona Know-How System Leaflet VPF-1, VPF-2, and Belzona Instructions For Use.
