# 50 YEAR OLD PLINTHS RESTORED WITH BELZONA

ID: 6013

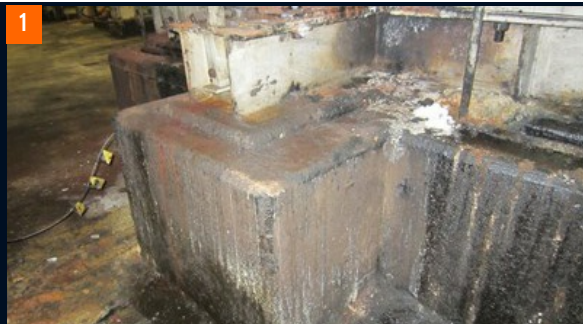
Brand new machinery was due to be installed in a 50 year old fertiliser plant where the concrete plinths holding the machines were heavily corroded and damaged.

1. Existing equipment supported by badly corroded concrete plinths
2. Belzona 4111 used to build up large gap between equipment and internal wall
3. Belzona 5811 and 4151 poured into former
4. New equipment with Belzona renovated plinths
