# BELZONA SEALS REMOTE PUMP HOUSE FLOORS

ID: 6092

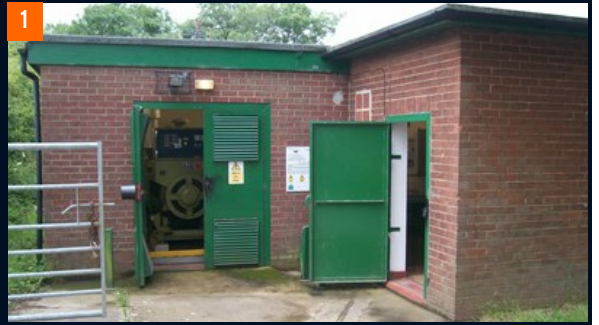
1. One of the remote pump houses
2. Existing floor during initial inspection
3. Belzona 2121 being applied to seal the edging trim
4. Application completed in 2011

Application was carried out in accordance with Belzona Know-How System Leaflets FPA-3 and FPA-7. Following surface preparation, 2 coats of Belzona 5231 were applied to the concrete floor. The joint between the steel edging trim and the floor was then sealed by applying a narrow band of Belzona 2121, reinforced with Belzona 9341.

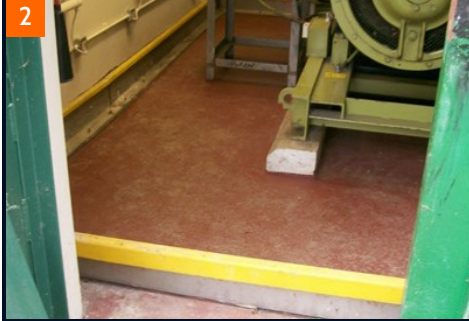
The client had a series of remote pump houses with diesel storage tanks inside and these facilities were seldom visited. Should there be a leak of diesel, it could be weeks before it was discovered and it was known that the floors would not hold fluids reliably. Previously the floors have been coated with a conventional solvent based paint and angled edging trims had been fixed to the floor to try and create a containment area. Both of which had failed.
