# WATER SUPPLY SAVED BY BELZONA

ID: 6096

Military Research Ship

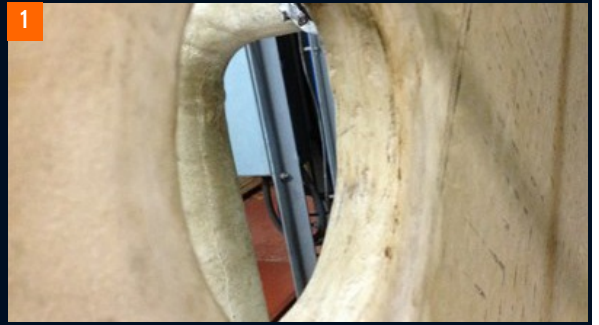
Sealing surface repairs seemed very difficult because of precision needed to seal flat plate heat exchangers within the distillation plant. Ship's schedule did not allow enough time for backing plate overhaul. Basic instruction assistance was provided by Belzona consultant and allowed ship's force engineers to complete rapid, permanent repair and get the water maker back in service. Soft backing plate coating failed on sealing surface and prevented double face rubber gasket from sealing sea water flow in a Alfa Laval Flash Type sea water Distiller.

1. Eroded bore in backing plate
2. Former in place
3. Square edge of sealing surface restored
4. Repair complete and ready for reassembly

The application was carried out in accordance to a modified version of Belzona Know-How System Leaflet ENC-6 Repair of Erosion of Ports with FORMING Technique. Former was created matching the required outside dimension. Release agent was applied to former after preparing substrate by hand with coarse sand paper. Belzona 1111 was applied to bore of damaged area and smoothed off with 90 degree side of application tool. Former was removed after a few hours and sealing surface dressed by draw filing.
